Messerschmidt Safety Consultants

5 January 2018

Re: Williams vs D&D Express

The following report summarizes my investigation into and analysis of the 24 April 2016 motor vehicle crash involving a 1995 Buick Roadmaster and 2008 Freightliner Cascadia. The 1995 Buick Roadmaster was being operated at the time of the accident by Mr. Daryl Williams. Mr. Lamario Henderson, Larry Henderson, and Jametrius McCon were riding as Mr. Williams' passengers at the time of the crash. The 2008 Freightliner was being operated by Mr. Adolfo Perez at the time of the crash. Mr. Carlos Laguna was riding as Mr. Perez's passenger at the time of the crash.

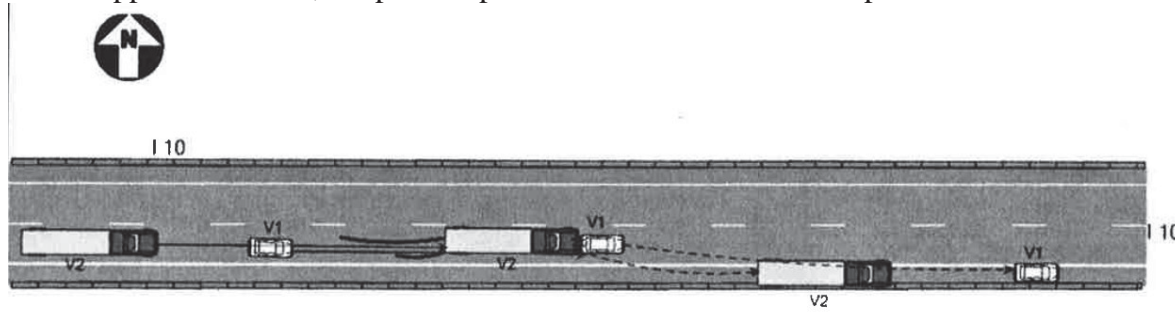
Figure 1: Diagram from Mississippi Uniform Crash Report

According to the crash report, the 1995 Buick was traveling in the right, outside lane. Mr. Williams indicated he ran out of gas and the vehicle came to an abrupt stop. The 2008 Freightliner was also traveling in the right, outside lane.

The collision occurred when Mr. Perez's 2008 Freightliner overtook Mr. Williams much slower-moving 1995 Buick and struck the rear offset slightly to the driver's side. After impact, both vehicles came to final rest in the eastbound emergency shoulder, facing east.

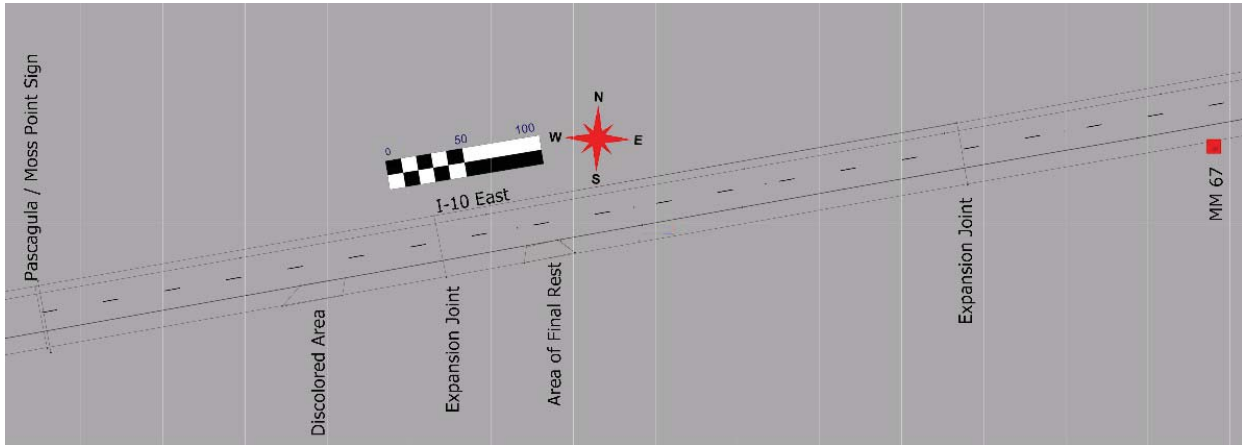
Figure 2: Diagram showing potential 2008 Freightliner final rest.

The location of final rest for the 2008 Freightliner was located using GPS coordinates and matching roadway markings found in trooper photographs with physical markings seen at the crash site.

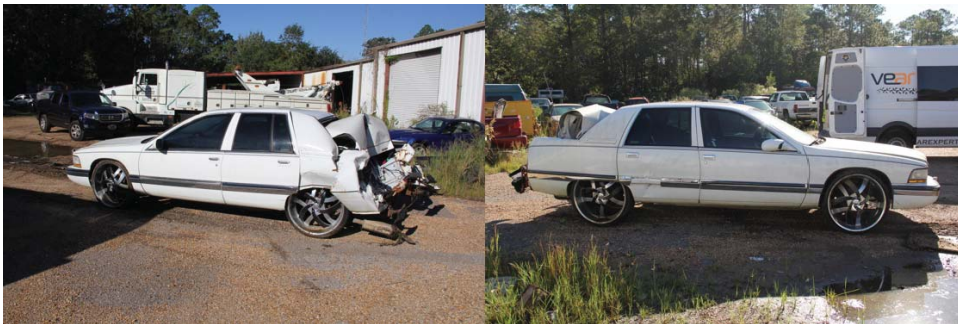
Photograph: 1995 Buick Roadmaster

On 17 October 2017, the 1995 Buick Roadmaster was inspected and photographed along with a lamp examination with Mr. Gary Johnson. It is a 4 door sedan with VIN 1G4BN52P2SR405417 and Mississippi license plate JHC689. The vehicle did not have any repairs completed between the time of the accident and time of inspection.

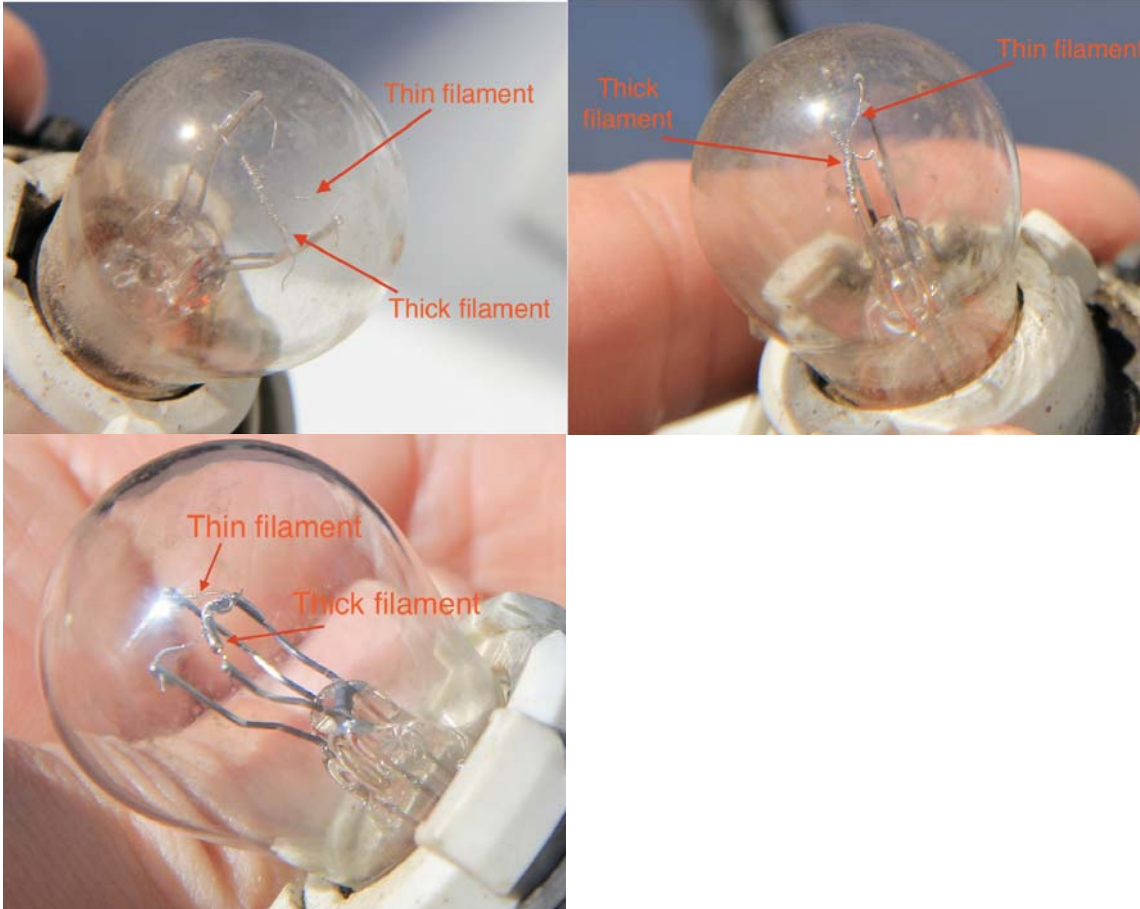
Excerpts: Taillight bulb inspection

The single filament bulbs that were inspected showed signs of "hot shock", which indicates the filament was incandescent or illuminated at the time of impact and the tail lights were on.

The dual filament bulbs that were inspected contain a thin wire and thick wire. The thin wire has a higher resistance to draw less current and give off less light, this wire is typically used for parking and tail lights. The thin wire filaments inspected did show signs of "hot shock" which again indicate they were incandescent at the time of impact and the tail lights were on. The thick

wire has a lower resistance to draw more current and give off more light, this wire is typically used for turn signals, brake lights, and hazard lights. The thick wire filaments inspected did not show the same clear indication of “hot shock”, instead they showed signs of bowing. Because both filaments are not equally deformed potentially indicates the thick wire filament was not incandescent at the time of impact and was hot because of it's proximity to the incandescent filament. There is not enough evidence at this time to determine the status of the hazard lights at the time of impact. (Baker) Therefore, one cannot state to a reasonable degree of scientific probability that the hazard lights were on or not on at the time of the collision.

1. The Freightliner was traveling 60-65 miles per hour, assuming the speed as testified by Mr. Perez.
2. The Buick's tail lights were on at the time of impact. There is not enough evidence to determine the status of the hazard lights at the time of impact. Therefore, one cannot state to a reasonable degree of scientific probability that the hazard lights were on or not on at the time of the collision.

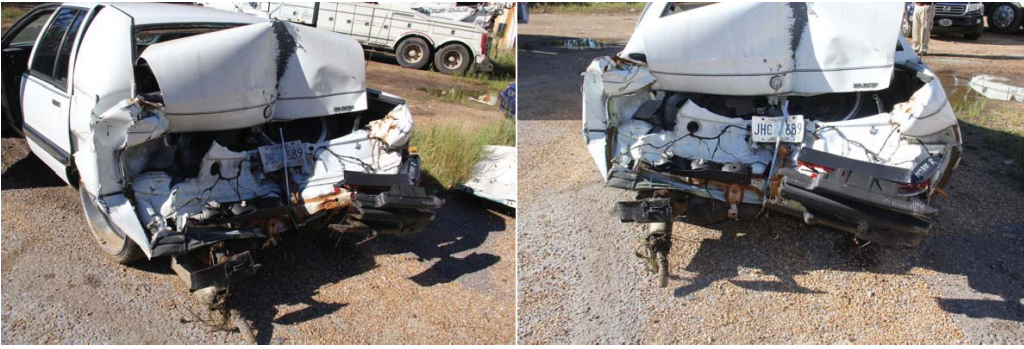
Photograph: Crush damage

The vehicle sustained damage to the rear, including damage to the rear bumper, trunk, and driver/passenger side quarter panels. Crush measurements were taken at the inspection to determine approximate closing speed. Based on these measurements, the Freightliner was offset to the driver's side slightly.

The closing speed at impact between the two vehicles was estimated by using crush stiffness coefficients and crush measurements applicable to the 1995 Buick Roadmaster. The coefficients were applied to the measurements of the approximate width and depth of the damage compared to published vehicle dimensions.

Based on the analysis of the damage, the closing speed at impact was calculated to be approximately 45 miles per hour. (Robinson) (Tumbas & Smith) If the Freightliner was travelling between 52-58 miles per hour, that would put the Buick's speed at impact between 7-13 miles per hour. This is inconsistent with Mr. Williams response to interrogatories that they were travelling approximately 58 miles per hour moments before impact. This is also consistent with McCon's medical records where he stated they were traveling no more than 10 miles per hour.

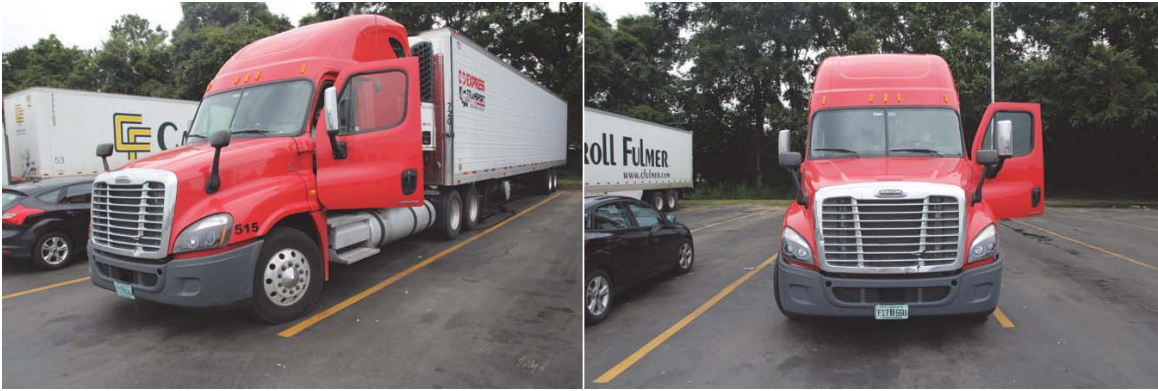
Photograph: 2008 Freightliner at time of download

On 15 June 2016, the 2008 Freightliner Cascadia was downloaded and photographed. The VIN was documented as 1FUJGLCK38LY72335 at this time with Florida tag F1766U. The tractor and trailer were both documented as D&D express with tractor number 515. At the time of this inspection, the majority of the damage to the tractor had been repaired, as the tractor had been put back in service. The front grille appeared to be the same as at the time of the accident. The ECM download was the only activity conducted, no other inspection of the tractor or trailer was done at this time.
